DEPARTMENT OF TRANSPORTATION

Quality Assurance and Source Inspection

Contract #: 04-0120F4Cty: SF/ALA Rte: 80 PM: 13.2/13.9File #: 1.28**WELDING INSPECTION REPORT****Resident Engineer:** Siegenthaler, Peter**Address:** 333 Burma Road**City:** Oakland, CA 94607**Report No:** WIR-022100**Date Inspected:** 21-Mar-2011**Project Name:** SAS Superstructure**OSM Arrival Time:** 700**Prime Contractor:** American Bridge/Fluor Enterprises, a JV**OSM Departure Time:** 1530**Contractor:** American Bridge/Fluor Enterprises, a JV**Location:** Job Site**CWI Name:** See Items Observed**CWI Present:** Yes No**Inspected CWI report:** Yes No N/A**Rod Oven in Use:** Yes No N/A**Electrode to specification:** Yes No N/A**Weld Procedures Followed:** Yes No N/A**Qualified Welders:** Yes No N/A**Verified Joint Fit-up:** Yes No N/A**Approved Drawings:** Yes No N/A**Approved WPS:** Yes No N/A**Delayed / Cancelled:** Yes No N/A**Bridge No:** 34-0006**Component:** Orthotropic Box Girders**Summary of Items Observed:**

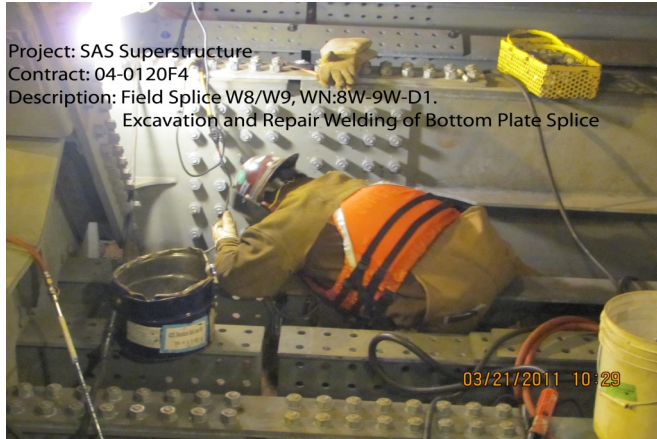
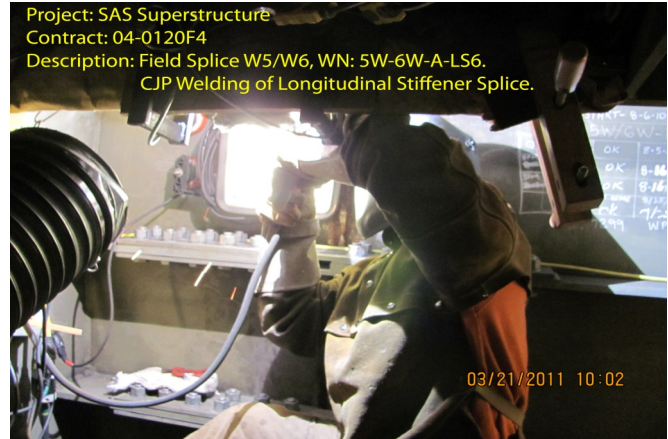
The digital photographs on page 3 of this report illustrate some of the work observed during this scheduled shift.
